## Field Damage Inspection and Static Load Test Analysis of Jiamusi Highway Prestressed Concrete Bridge in China

In this paper, Jiamusi highway prestressed concrete bridge is inspected by the team of inspection in School of Transportation Science and Engineering/ Bridge and Tunnel Engineering/ Harbin Institute of Technology (HIT) in China to identify damaged members and evaluate the performance of the bridge structure under dead load, live load, and environmental conditions.

Jiamusi highway prestressed concrete bridge is located in the Jiamusi City within Heilongjiang province in the east north of China. The total length of the bridge is 1396.2 m and the width is 17 m. The bridge was open to traffic in September 1989. The type of the bridge is a continuous prestressed concrete T-shape rigid frame with hanging beams and simply supported T-beams. T-shape rigid frame structure consists of prestressed concrete box girders. Fig. 1 shows the layout of the bridge structure and Fig. 2 shows the pier and span prestressed box girder layout.

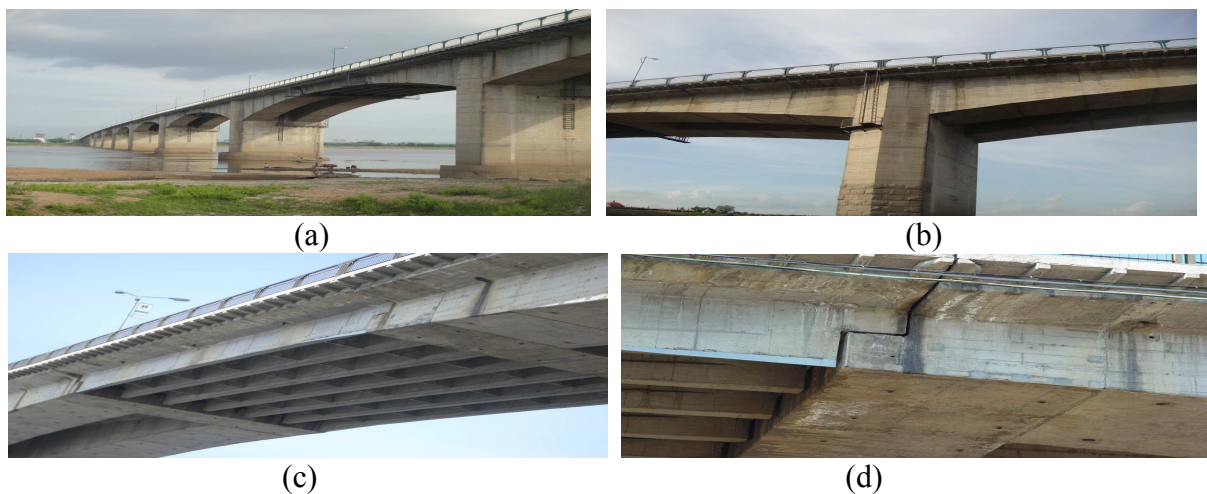
Fig. 1 View of bridge structure: (a) Spans of bridge view, (b) T-shape structure, (c) Hanging beam between two T-shape structure, (d) Corbel view

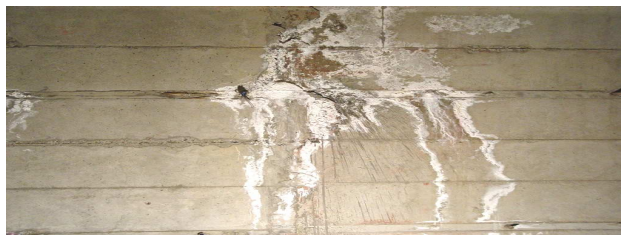
There are pieces of white substance in the outside of the web in box girders from the corbel to  $\frac{1}{2}$  of T-shape cantilever structure (from block No. 7 to block No.11). These pieces of white substance distribute in the surrounding of the vents. The second differential method is adopted to test the components of the white substance. The most part of the white substance is made of sodium bicarbonate ( $\text{Na}_2\text{H}(\text{CO}_3)\cdot 2\text{H}_2\text{O}$ , 72% of content), and sodium carbonate ( $\text{Na}_2\text{CO}_3\cdot 2\text{H}_2\text{O}$ , 19%). The small part is made of potassium bisulfate ( $\text{KHSO}_4$ , 8%). The white marker is the apparent feature of corrosion of concrete. The serious part can cause to crack the surface of the concrete, and also the steel can be corroded, due to invading of the chloride ions. This has a strong impact on the durability of the concrete structure. The components of white substance are listed in Table 1.

Fig. 3 White substance in the web of box girder

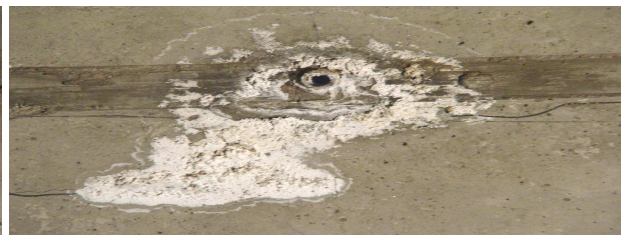
There are leakages occur in the holes of the box girder top due to damage of deck pavement and leakage of water through pavement layer to the top of box girders. Fig. 3 shows the white substance and Fig. 4 shows the leakages of holes.

Fig. 4 Leakage of hole in the top of box girders

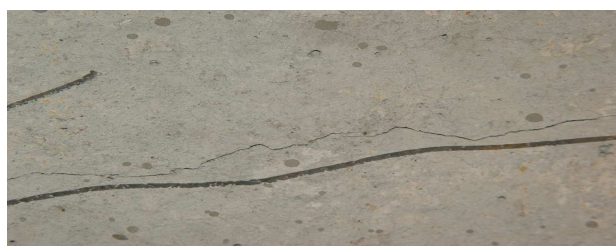
There are many diagonal cracks in the inside web of box girder in the part from the corbel to  $\frac{1}{3}$  of T-shape cantilever structure (from block No. 8 to block No.11). The oblique angles of diagonal cracks rang between  $30^\circ$  to  $45^\circ$ . The main causes of diagonal cracks are excessive principle stresses. The length and width of cracks rang from 2cm to 6cm and 0.1mm to 0.2mm respectively. Fig. 5 shows the diagonal cracks in the web of box girder. There are not cracks in the outside web of box girder. There are five longitudinal cracks in the inside web of box girder of block No. 9 and the maximum width of cracks is 0.06mm. Fig. 6 shows the longitudinal cracks.

Fig. 5 Diagonal cracks in web of box girder

**Cracks Observation.** Two tested points are selected in block No.8 within the cantilever span in the web of box girder to observe the development of diagonal cracks. For longitudinal cracks, one tested point adopted. The results of cracks observation show that there is not change in the length of diagonal cracks in the web of box girder when the load test is applied, and the maximum width of crack has a little changing. The increasing of crack width is about 0.01mm, indicating that the direct reason of the diagonal cracks producing in the web of box girder are not due to live load, but due to the combination of prestress forces, dead load, shrinkage, and creep of concrete.

3. Because of there are diagonal and longitudinal cracks in the web of box girders and there is down deflection in the corbels, there is need to strengthen the main span of the bridge by using external prestressing tendons and repair other damage structural members.

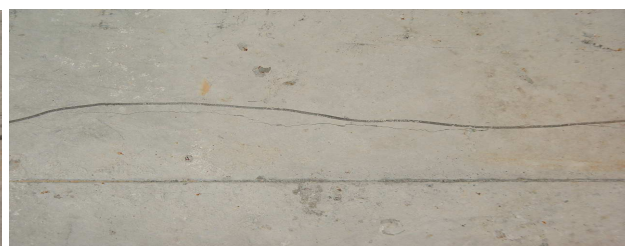
Fig. 6 Longitudinal cracks in web of box girder.

The longitudinal cracks in the top of box girder web are developed. The width of crack increases about 0.04mm and the maximum crack width is about 0.11mm. The length of crack increases about 2.7mm. It indicates that the cracks in the box girder top are produced from bending moment. However, the width of cracks is less than the allowable value (0.2mm). There are not visible cracks near corbel.

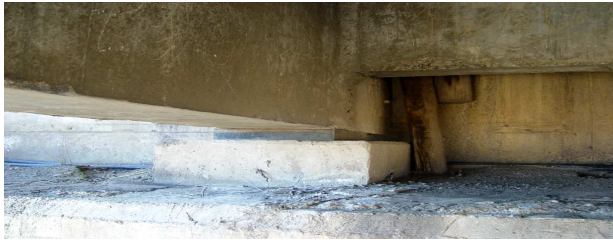
**Inspection of Box Girders.** After inspection of the bridge approach supports, it is found that the bearings are clean, the structural performance of bearings in good state, and there is not any damage in the bearings. Fig.7 shows the bearings of approach supports and Fig. 8 shows the bearing of simply supported T-beams.

Fig. 7 Bearings of approach supports

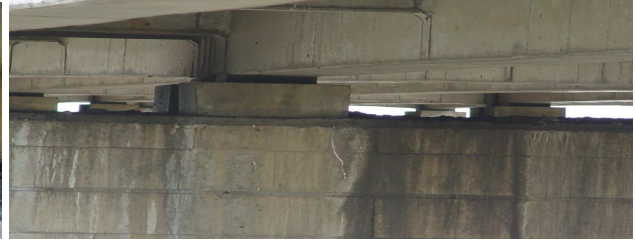
Fig. 8 Bearing of simply supported T-beams

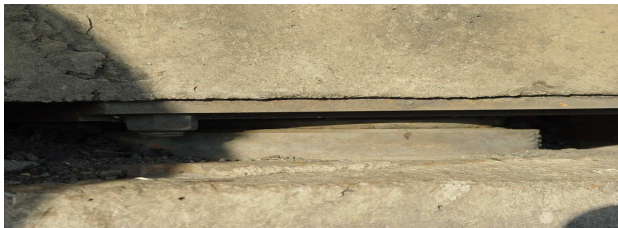
There is not any damage in bearing of corbels, but there is mixed soil accumulating from the deck, influencing the normal operation of the bearing. After checking the corbels, it is found that there is not any crack in the corbel. The hanging beams are checked by using the bridge checking car. According to inspection of hanging beams, there is not any visible crack in the fulcrum of the hanging beams and the quality of concrete in good state. Fig. 9 shows bearing of corbel and Fig. 10 shows the hanging beam in the part of corbel. Fig. 11 shows the bridge checking car which is used in the inspection of bridge structural members.

Fig. 9 Bearings of corbel

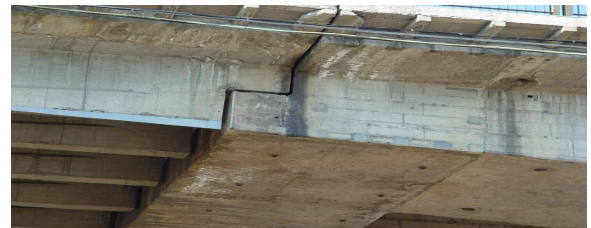
Fig. 10 Hanging beams in the part of corbel

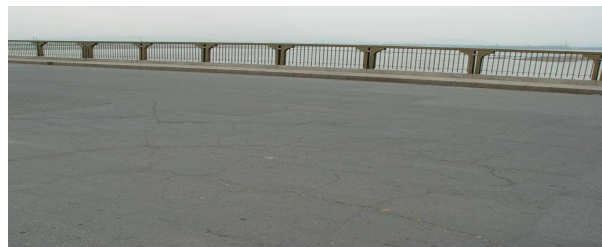
**Inspection of the Bridge Deck Pavement.** After inspection of deck pavement, the surface layer of asphalt has serious damage, resulting the deck uneven. Deck pavement suffers from serious cracks, spalling, and exposing of the waterproof concrete. Fig. 12 shows the cracks of deck pavement and Fig. 13 shows the spalling of asphalt layer.

Fig. 12 Cracks of deck pavement

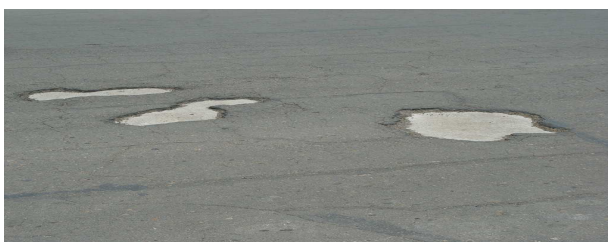
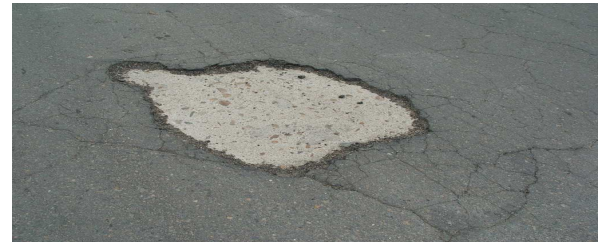
Fig. 13 Damage of deck pavement, (a) Spalling of asphalt, (b) Exposing of the waterproof concrete

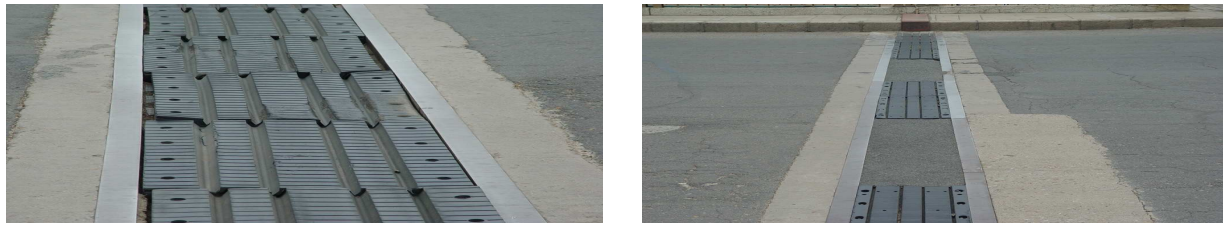
**Inspection of Expansion Joints.** Expansion joints suffer from serious damage such as deformation of expansion joint rubber, dislocating, shedding, and cracking. Fig. 14 shows the damage of expansion joints.

Fig. 14 Damage of expansion joints: (a) Deformation of expansion joint, (b) Losing of function of expansion

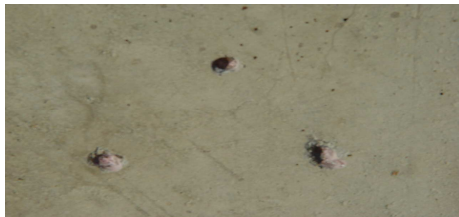
**Concrete Carbonation Test.** In this study, the drilling method is applied to measure the depth of concrete carbonation for the inside and outside web of the box girders and piers. For inside web of the box girders, three sections are selected to measure the depth of concrete carbonation. These sections are ends,  $L/4$  span, and the top of T-shape cantilever structure. But, for outside web of box girders, two sections are selected to test. There are two tested areas in each section and three holes for each tested area. The test results indicate that the depth of concrete carbonation is small and range between 0.5mm to 1mm. After scattering the chemical indicator, the color changes to purplish red, it proves that the concrete has no carbonation. Fig. 15 shows the tested area and Fig. 16 shows the carbonation for inside and outside web of box girders.

Fig. 15 Tested area

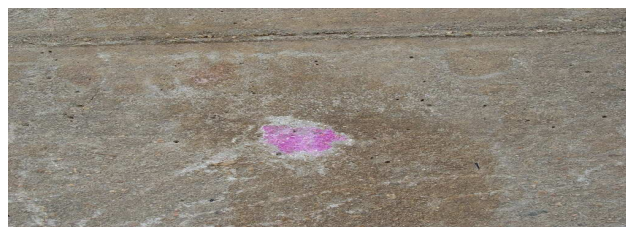
There are two piers are selected to measure the depth of carbonation. These piers are pier No. 1 and 2. Two tested areas are selected. From the test results it can be noted that the average depth of concrete carbonation is 0.5mm. Also After distribution the chemical indicator, the color changes to purplish red, it indicates that the concrete has no carbonation. Fig. 17 shows concrete carbonation of piers.

Fig. 17 Concrete carbonation of piers.
