The Twelfth East Asia-Pacific Conference on Structural Engineering and Construction

## Damage Investigation, Strengthening, and Repair of Jilin Highway Double-Curved Arch Concrete Bridge in China

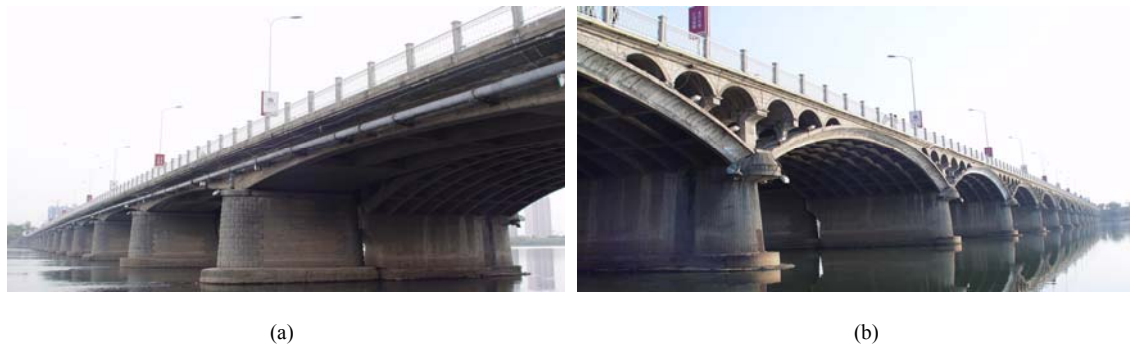
Figure 1: Jilin highway double-curved arch concrete bridge (a) side view of the old simply supported beam bridge, (b) side view of the new arch bridge

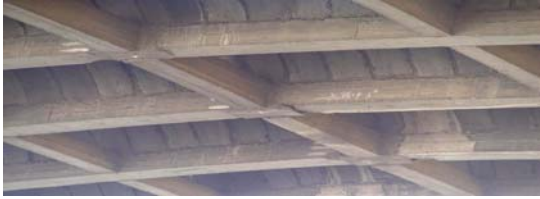
According to the results of damage investigation of the bridge structure appearance, the quality of main arch ring and horizontal tie beam is good. There are not series cracks for the structure. Because of the vertical cracks in the parts of arch wave, the whole mechanical performance of main arch is affected by the cracks. There are serious damages in the part of spandrel arch, resulting in larger deformation of structure. There are cracks within deck pavement. Because of these damages within the spandrel arch and damages of deck pavement, the recommendation of this study is to strengthen and repair the spandrel arch and pavement of deck. For old simply supported bridge, there are some serious cracks in the main beam and lifting beam of the simple beam bridge. The whole state is good, but there are serious corrosion and spalling of concrete in the corbel. These damages influence the strength and durability of the bridge structural members. Therefore, there is a need to repair the corbel. Figures 3, 4, 5, 6, 7, 8, 9, and. 10 show the damages of bridge structure members.

Figure 3: Damage of arch ring

In order to enhance the stiffness and carrying capacity of the main arch ring integrity, the main arch ring is strengthened by using jacketing method. This method consists of two stages. The first stage is planting steel bars, and the second stage is spraying the concrete. In this method, the materials are used in the strengthening process include steel bars, C-30 anchor spray cement concrete and glue materials. The thickness of spray concrete is 6 cm in the parts of arch ribs and arch wave, and the inserted depth of anchor bars must be more than 8 cm with weld length more than 12 cm. The difference between concave and convex of the exposed face must be less than 1.5 cm after construction completion. To improve the carrying capacity of the arch bottom, cast-in-situ C-30 concrete is used with 10 cm thickness, and the longitudinal steel bars must be inserted in arch abutment to endure the tension in the higher edge of arch bottom. Planting steel bars process includes many stages. These stages are prepare for planting steel bars, drill the holes accordance to required depth and diameter, clean the holes by compressed air, inject the glue materials by using glue guns, insert the steel bars to the bottom of the holes, weld and connect the bars after consolidation of the anchor agent, check whether the anchoring force satisfy the designed requirement by the in-situ pullout test for the bolts in the important parts, and the steel mesh is connected with planted steel bars. Spraying the C-30 concrete process adopts the mean of wet shotcrete technology. Figures 11, 12, 13, and 14 show the strengthening process of the main arch rings.

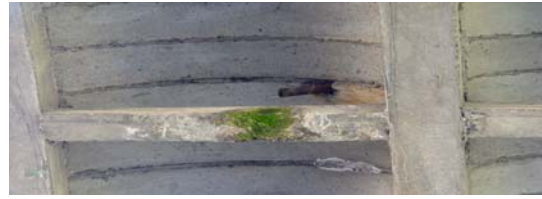
Figure 4: Damage of horizontal tie beam

The method of grouting repair is adopted to repair the cracks in the parts of horizontal tie beam, arch wave, the higher edge of arch bottom, the interior edge of arch top, mid-span of the main beam, and the higher edge of pier top of the old simply supported beam bridge. For cracks width less than 0.15mm, the grouting method stages include clean and remove the laitance and dust; dig a V-shape groove by using chisel; adhesive sealing the cracks by using the mixed epoxy resin No. 6101. The cracks are leveled by using scraper. The compressive strength of mixed adhesive is more than of concrete. For cracks width

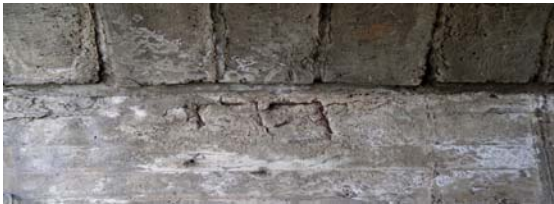
Figure 5: Damage of pier cap beam

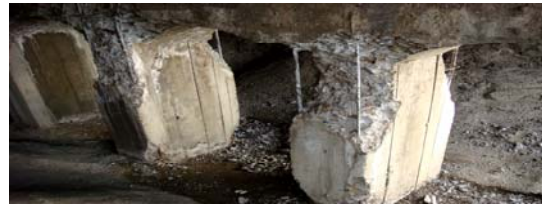
Figure 6: Damage of spandrel arch piers

There are serious damages in the parts of spandrel arch, especially in the piers. These damages include the spalling of concrete and corrosion of steel reinforcement. The strength of concrete is low. Therefore,

there is need to improve the carrying capacity of spandrel arch piers. Two methods are used to strengthen the spandrel arch parts. The first method is known as patching method which is used to strengthen the pier cap by using the epoxy resin concrete after removing the corroded concrete surface and clean the steel reinforcement. The second method is used to strengthen the pier of spandrel arch by using double layers of AFS-90 (Aramid Fiber Sheets). This method consists of five stages. These stages are: preparing the base surface of concrete, brush the glue material, repair the lower parts on the surface by using the glue to get suitable level and ensure the smooth of the pasting surface, and pasting the aramid fiber sheet (AFS-90), Protection of overlay.

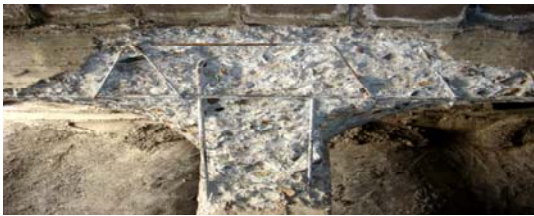
Figure 7: Damage of pier and pier cap

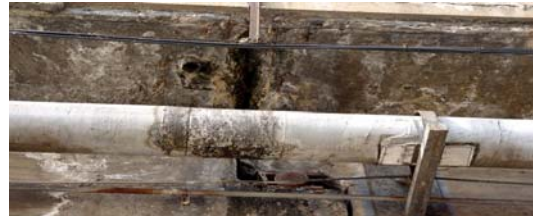
Figure 8: Damage of drainage system

Repair process of the old simply supported beam bridge damaged parts include repair of corbel roller supports by using derusting and covering oil, re-install the expansion joints in every corbel, repair the sidewalk which that contains on electrical line, repair the concrete of lifting beam and bottom of the box beam by removing the corroded concrete and applying the epoxy resin concrete, and re-set the drainage system of the bridge deck by using the new drainage pipes and  $\phi 100$  PVC pipes.

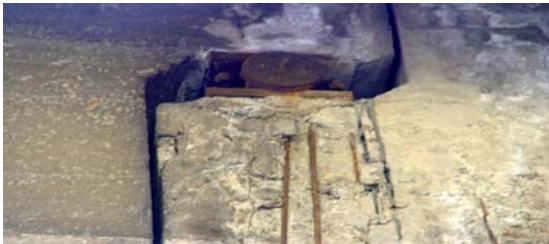
Figure 9: Damage of bearing and corbel

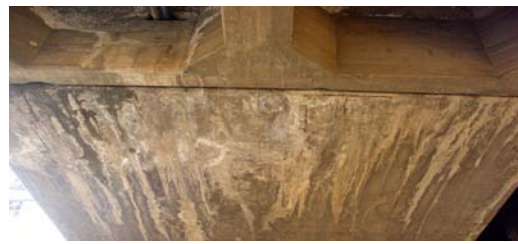
Figure 10: Damage of simply supported bridge

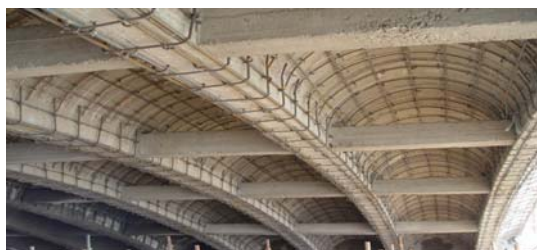
Figure11: Planting steel bars in arch rings

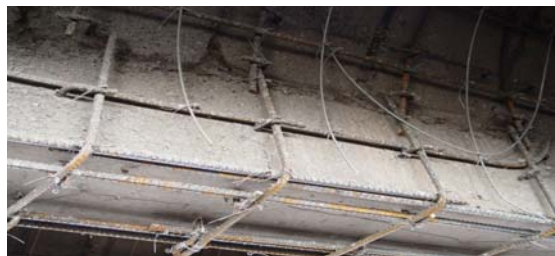
Figure12: Planting steel bars in arch rib

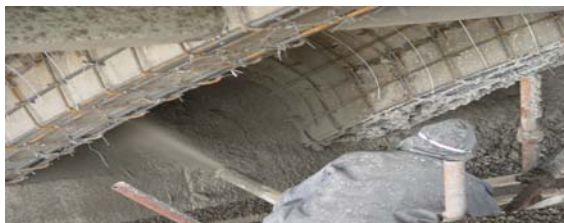
Figure13: Spraying the concrete

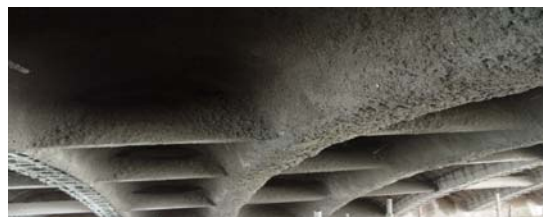
Figure 14: The first layer of sprayed concrete

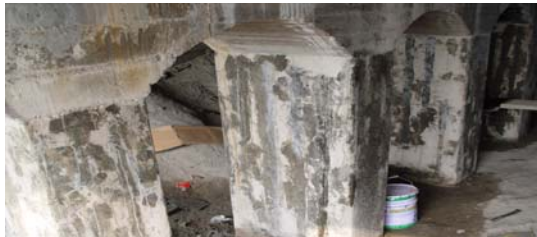
Figure 15: Repair the piers of spandrel arch

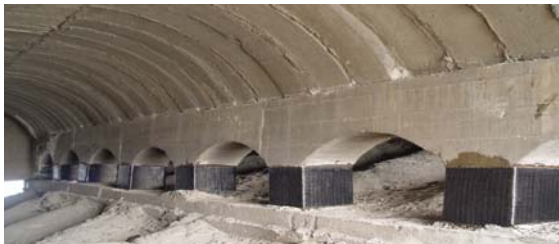
Figure 17: Spandrel arch piers strengthening

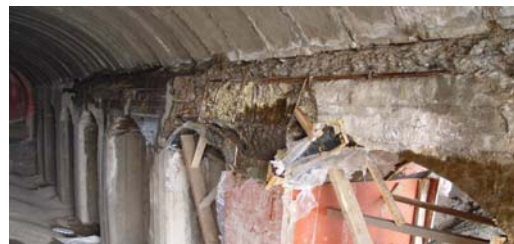
Figure 18: Pier cap repair
