# Experimental Analysis and Performance Evaluation of Fu Feng Highway Prestressed Concrete Bridge After Strengthening in China

Ali Fadhil Naser<sup>1, a</sup>, Zonglin Wang<sup>2, b</sup>

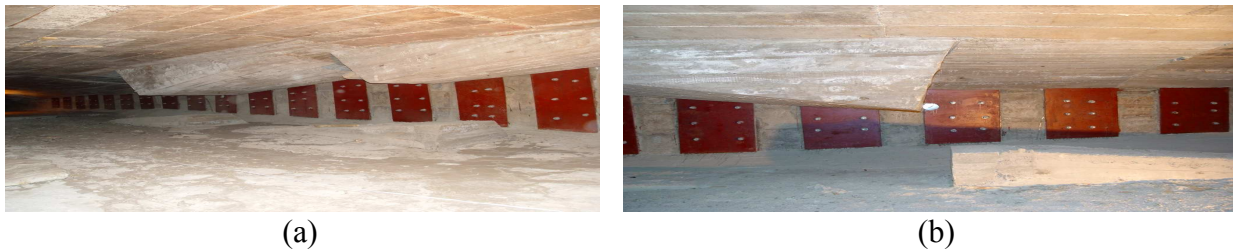
**Strengthening of the Box Girder Web.** Steel plates are used in the strengthening of box girders web. Steel plates are pasted in the inside of the right and left of box girders. The steel plates are a kind of A3 steel and have thickness of 8mm. Fig. 3 shows the strengthening of box girders web by using steel plates.

Fig. 3 Strengthening of box girders web: (a) right web of box girder, (b) left web of box girder

- 1- The strengthening process of damaged structural members includes three stages. The first stage includes the strengthening of box girders floor by casting of 10cm of reinforced concrete in the floor of box girder within the location of positive bending moment in the mid-span and edge span. The second stage includes strengthening of box girders web by pasting steel plates in the inside of the right and left of box girders. The third stage includes strengthening of the transverse beam of piers No. 18 and No. 19 by using carbon fiber sheet.

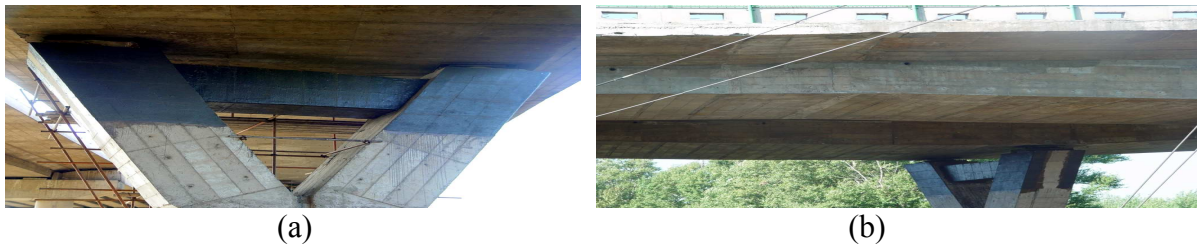
**Strengthening of transverse beams of Y-shaped pier.** Carbon fiber sheet is used to strengthen the transverse beam of piers No. 18 and No. 19. Fig. 4 shows the strengthening of the transverse beam of Y-shaped piers.

Fig. 4 Strengthening of the transverse beam of Y-shaped piers: (a) front view, (b) side view
